**Petition for the Reconsideration and
Modification of the National
Transportation Safety Board's Findings
and Determination of the Probable Cause
for the Crash of TWA Flight 800**

The TWA 800 Project
6/19/2013

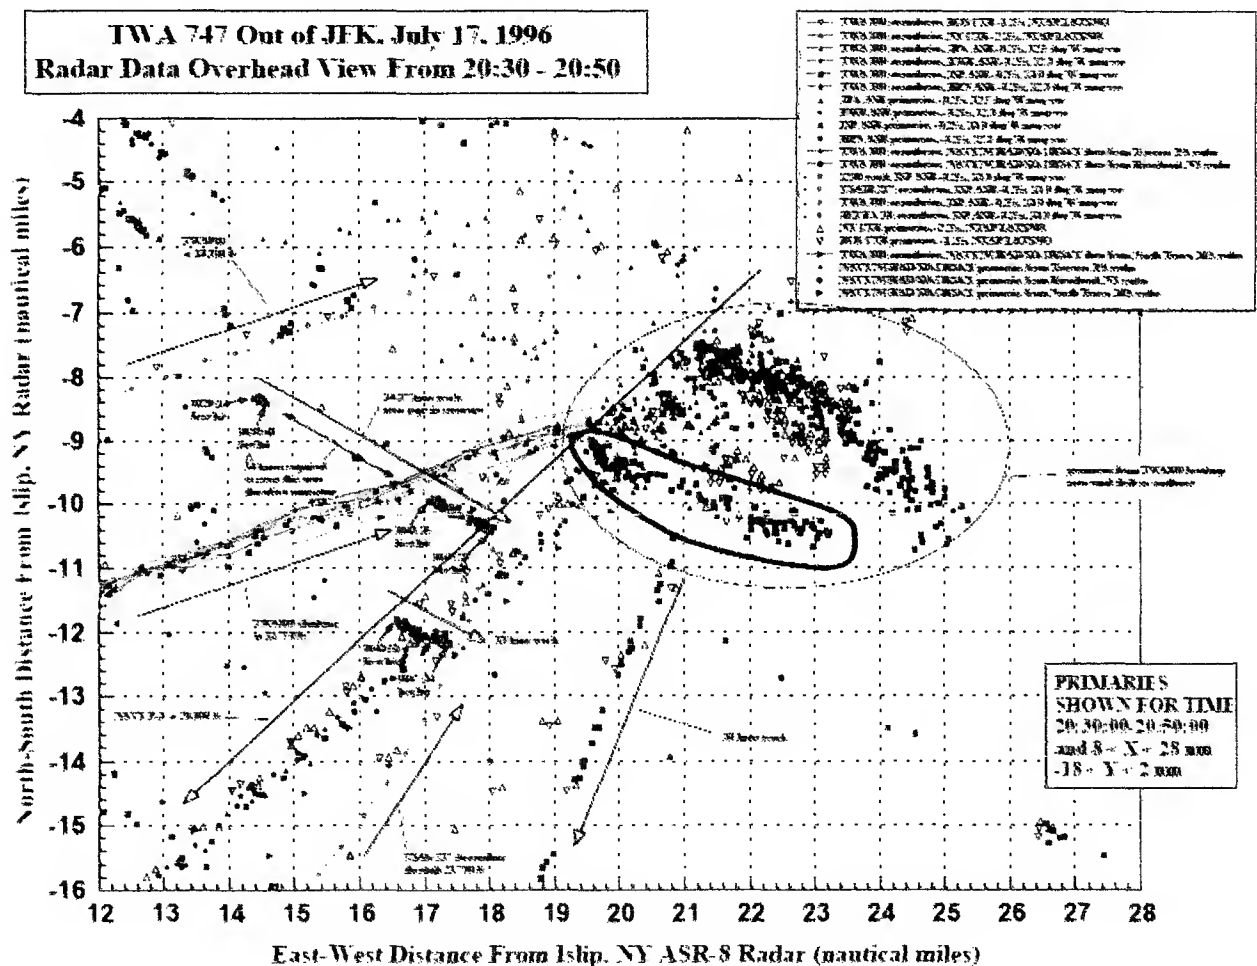
Within 8.5 seconds of TWA Flight 800 losing electrical power, a heavy concentration of light debris began appearing on the FAA radar between 1/3 and 1/2 mile due south of and almost perpendicular to TWA Flight 800's flight path. The majority of this debris stopped most of its horizontal motion and began falling to the ocean 1/2 mile south of where TWA Flight 800 lost electrical power. As it fell to the ocean, the wind carried this debris toward the SE for more than ten minutes. The Islip, White Plains, and JFK radar sites recorded the debris as it fell. When plotted over time, the radar returns from this debris appear as a distinctive, diagonal band, as shown on the NTSB radar plot below.

Figure 1: NTSB radar plot from page 44 of the Airplane Performance Study (Exhibit 13A). The band of debris in question has been circled by the petitioners with a thick black line.

At the 1997 NTSB hearing in Baltimore, NTSB investigator John Clark testified that the above-mentioned plume of radar returns (circled with a thick black line above) was “consistent with the explosion” that caused the crash. However, Mr. Clark did not provide a scientific basis for that conclusion nor did he attempt to further characterize that explosion by presenting an analysis of the subject radar returns. Our analysis of the speed and direction of the circled radar returns presented below demonstrates that the explosion responsible for the propagation of these returns was, in fact, a high velocity explosion—a detonation. The official NTSB theory for the crash is based on the assumption that the explosion in question was a low-velocity explosion or deflagration of fuel-air vapors and therefore cannot account for this radar-recorded detonation.

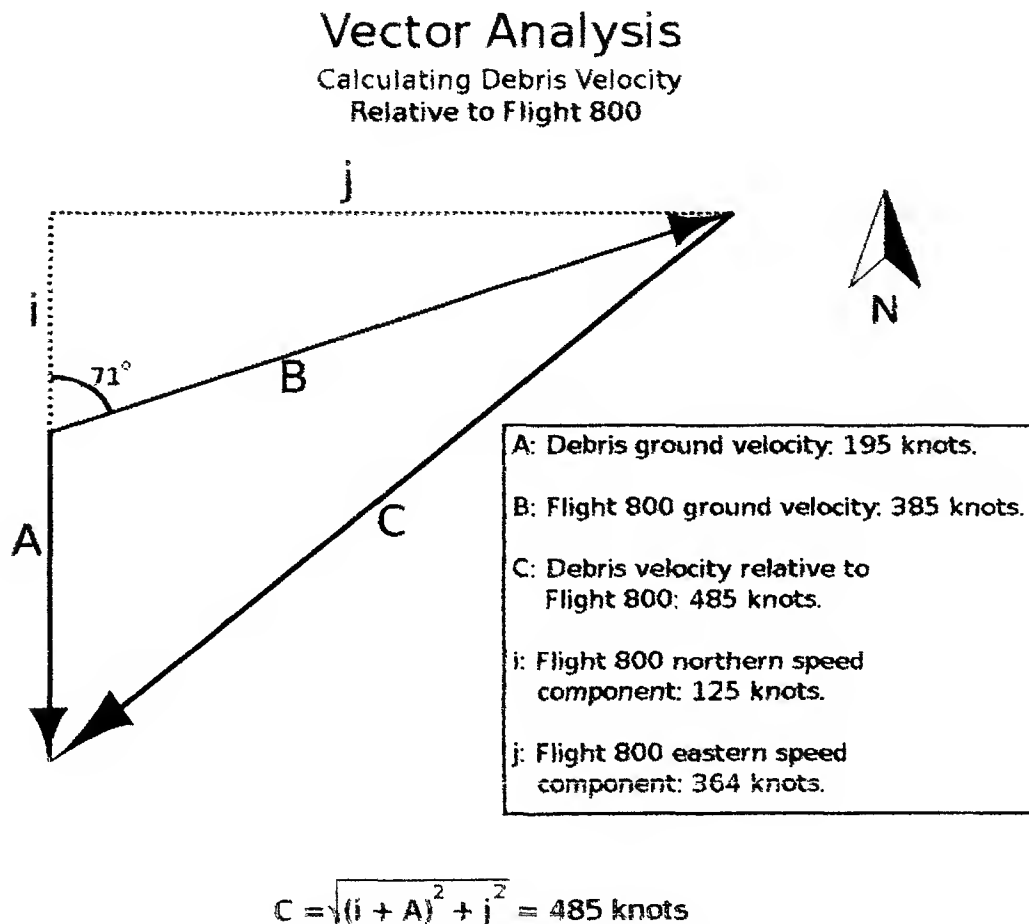
Using the Pythagorean Theorem, the average speed of the debris relative to the accident aircraft was between 463 and 495 knots or between 238 and 255 m/s.

Figure 2: Addition of Flight 800 and debris velocity vectors. The blue line labeled C represents the debris' velocity relative to Flight 800. Lines A and B represent the ground velocities of the debris and Flight 800 respectively. Lines i and j represent Flight 800's northern and eastern speed components.

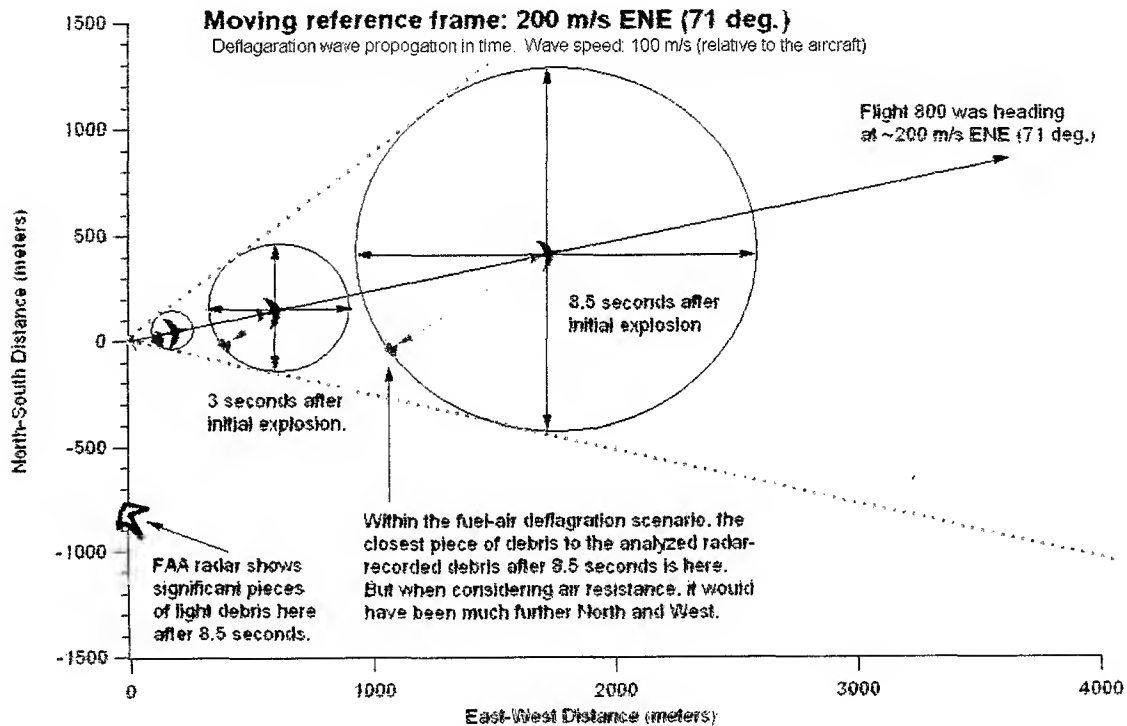
Figure 3: Maximum deflagration wave expansion at three points in time in TWA Flight 800's reference frame. Air resistance is neglected outside the aircraft to provide a best-case scenario for the NTSB's crash sequence. The red arrows point to hypothetical debris ejected by the deflagration. The 747 icons are not to scale.

In Figure 3, the circles represent the maximum expansion of the officially proposed fuel-air deflagration. The red dotted lines represent the maximum horizontal distance any piece of debris could have traveled in the first moments after the explosion. The hypothetical wreckage item colored red at the lower left edge of each circle represents the most dense and streamlined wreckage fragment, since the effects of air resistance would be lowest for such fragments. But as can be seen, even a fragment with those properties would still be more than one kilometer away from where radar sites recorded the debris plume at 8.5 seconds.

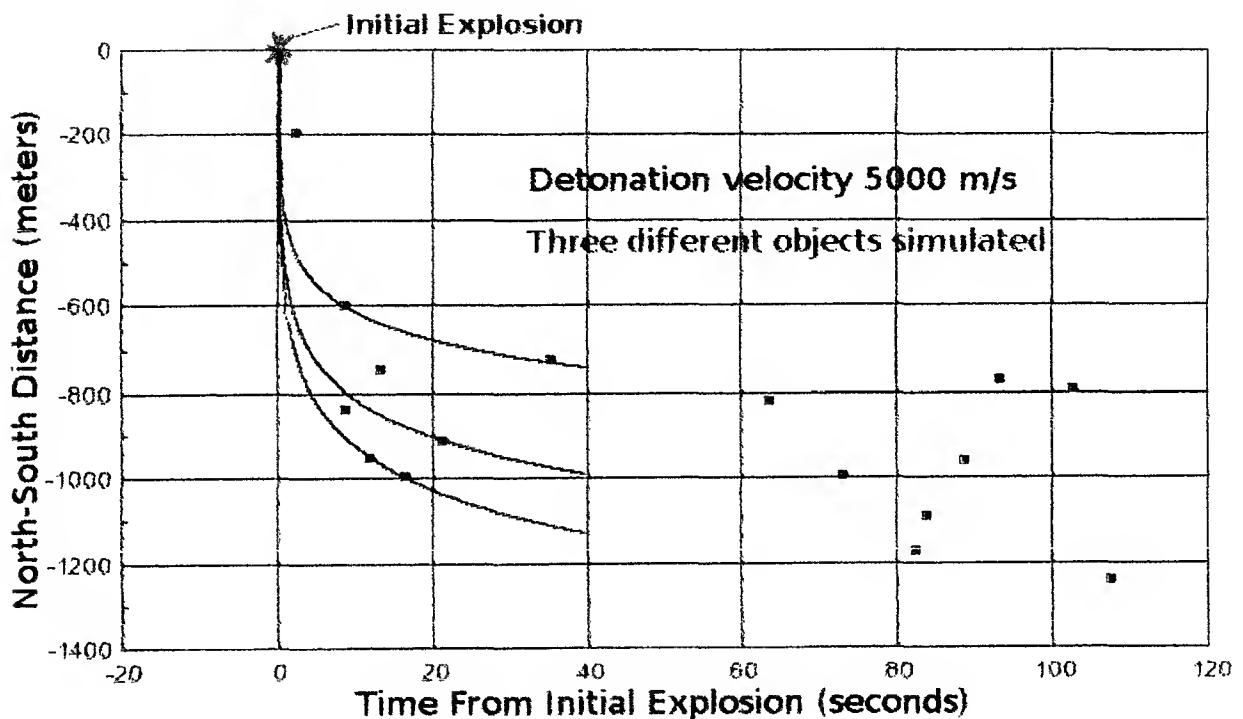
Figure 4: Three ballistics curves fit to north-south position vs. time from the Islip and White Plains radar sites. This plot only shows the north-south distances and speeds. Flight 800 was heading ENE at 385 knots. The small blue squares are a composite of Islip and White Plains FAA radar returns.
